# 1971 Mustang Mach 1

## Body and refinishing estimate

**Estimate C4STANG-BODY-R2 | October 14, 2026 | Preliminary scope for review**

## Pre Restoration Condition Report

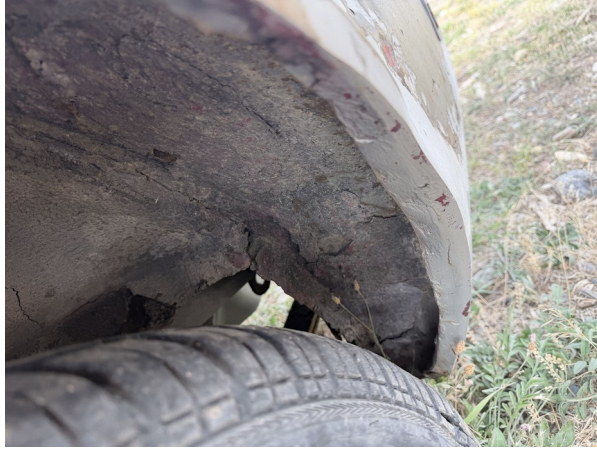
| Area and photo evidence | Visible condition | Working disposition |
|---|---|---|
| Rear wheelhouses and adjoining lower body<br>0587-0593 | Visible holes, heavy scale, cracked coatings and deteriorated seams. Several close-ups show loss of metal, not just surface oxidation. | Metal repair required. Outer wheelhouse replacement is likely; inner sections and adjacent drops need exposure. Confirm exact side and boundaries. |

IMG\_0587.jpeg — Wheelhouse opening with deteriorated metal and coating.

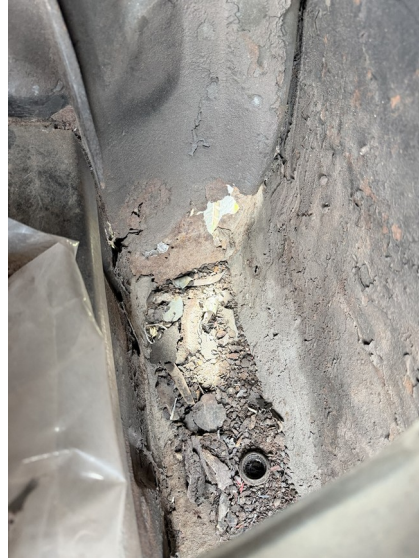
IMG\_0590.jpeg — Interior rear cavity with extensive perforation and scale.

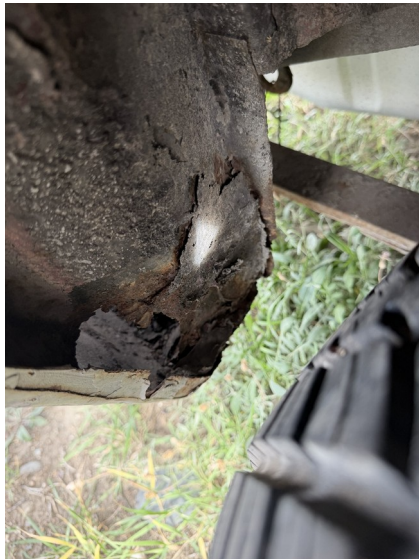
IMG\_0592.jpeg — Lower wheelhouse or adjoining rear sheetmetal with rust-through.

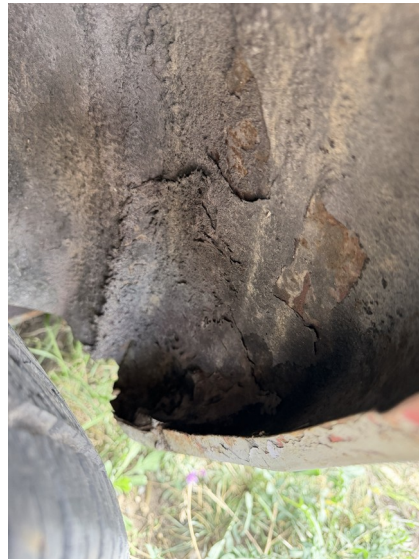
IMG\_0593.jpeg — Lower rear sheetmetal with a large irregular perforation.

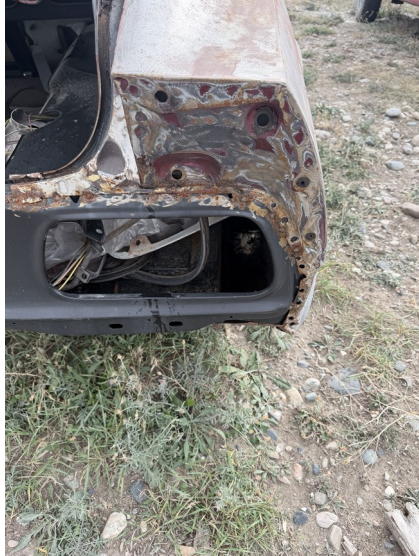
| Area and photo evidence | Visible condition | Working disposition |
|---|---|---|
| Rear lamp panel and corners<br>0578-0579 | Corrosion, irregular repaired surfaces and deteriorated edges/flanges around rear openings. Lamp assemblies are absent from openings. | Repair or replace affected sections; determine whether full rear panel replacement is justified. |

IMG\_0579.jpeg — Rear lamp opening and trunk-corner corrosion/previous work.

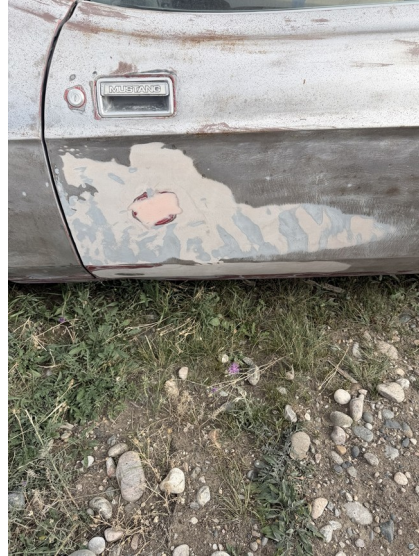
| Area and photo evidence | Visible condition | Working disposition |
|---|---|---|
| Doors<br>0580-0581, 0600 | Exposed filler or repair layers, especially lower door areas. Door-to-fender fit is uneven in the photographed condition. | Pending stripping; check skins, hems, inner bottoms, hinges and latch fit. |

IMG\_0581.jpeg — Lower door showing exposed filler and repair layers.

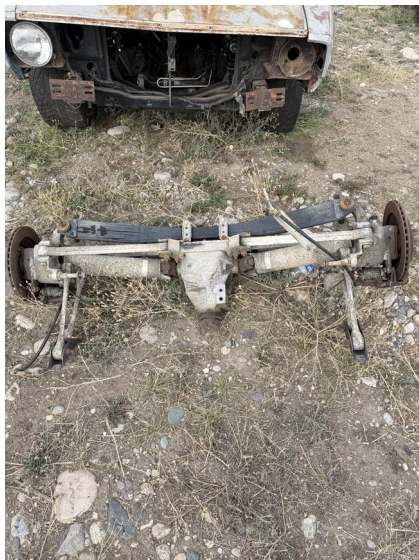
| Area and photo evidence | Visible condition | Working disposition |
|---|---|---|
| Loose rear suspension assembly<br>0573-0574 | Independent suspension with differential, halfshafts, disc brakes and transverse leaf spring. Appears consistent with a Corvette-style donor unit. | Confirm identity and project intent. It is not the factory front suspension; compatibility and condition are unverified. |

IMG\_0573.jpeg — Loose independent rear suspension assembly; donor identity unverified.

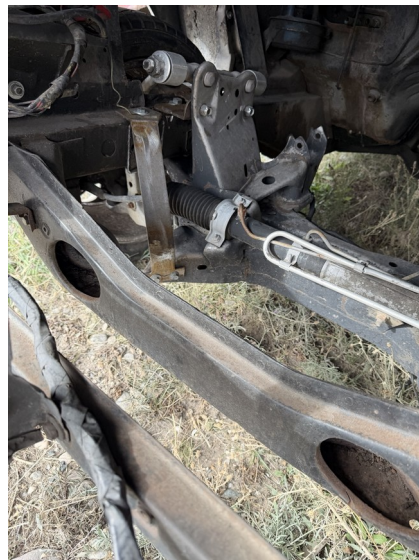
| Area and photo evidence | Visible condition | Working disposition |
|---|---|---|
| Front suspension and steering<br>0596-0598 | Rack steering and a nonfactory crossmember/bracket/control-arm arrangement are visible. | Identify donor/kit and installation; inspect mounting, welds, fasteners, travel and alignment relationships. |

IMG\_0597.jpeg — Front rack/crossmember and modified mounting arrangement.
